Chimney Fires: Causes, Effects & Evaluation

Chimney Safety Institute of America

Chimney Fire Education and Research Task Force

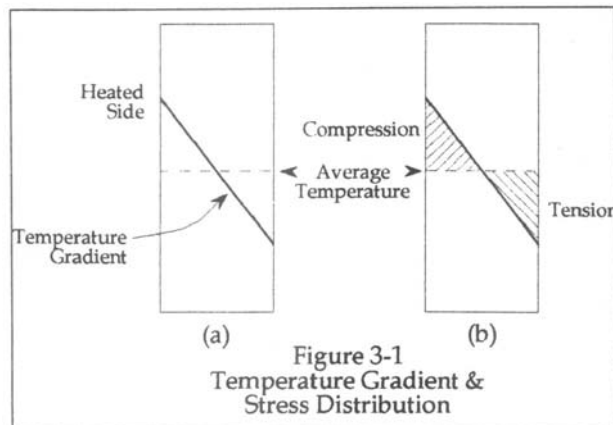
Any part of the object which is either warmer or cooler than the average temperature will be under stress. As shown in Figure 3-1(b), in part of the material the stress will be in the form of *compression* and part in the form of *tension*. The half of the object which is warmer will be under compression because it is expanding against the restraint of the cooler half. The cooler side will be under tension because it is resisting the expansion of the warmer half. At any point through the cross-section of the object, the amount of either tensile or compressive stress will

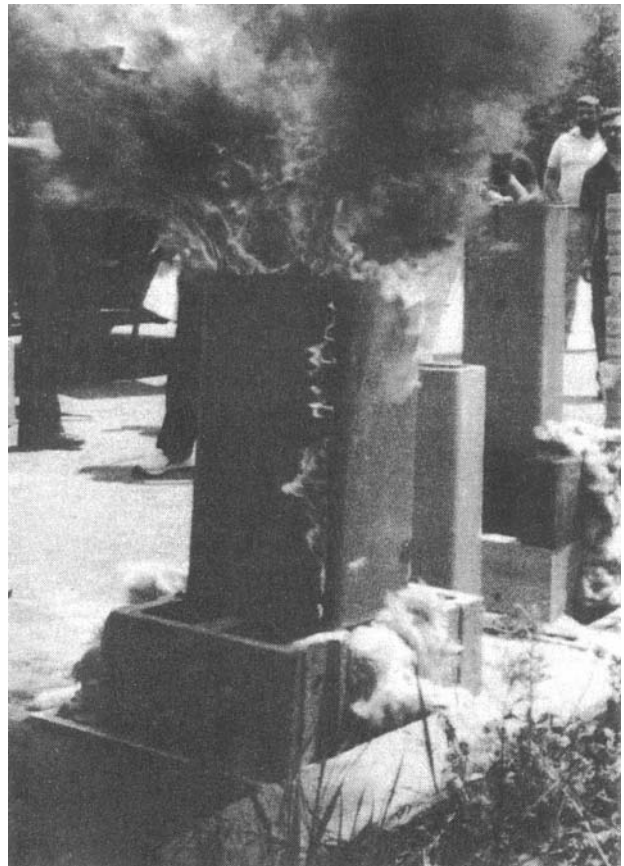
Figure 3-9. In this photograph of a demonstration chimney fire, a clay flue liner, its interior coated with tar, has been ignited to simulate a chimney fire. Notice the severe crack at the near corner and the flame escaping the confines of the liner.

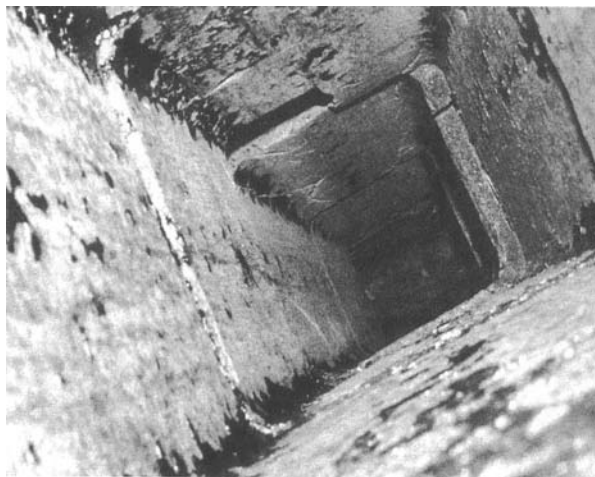
Figure 4-1. The interior of a clay flue tile-lined chimney illustrates the impact of a chimney fire – multiple cracks in tile liner sections and a missing segment of tile which fell down into the smoke chamber/damper area.
